C WOOD & SON
LUTON LTD

Case Study

Cow Shed to Property Conversion
Gaddesden Row

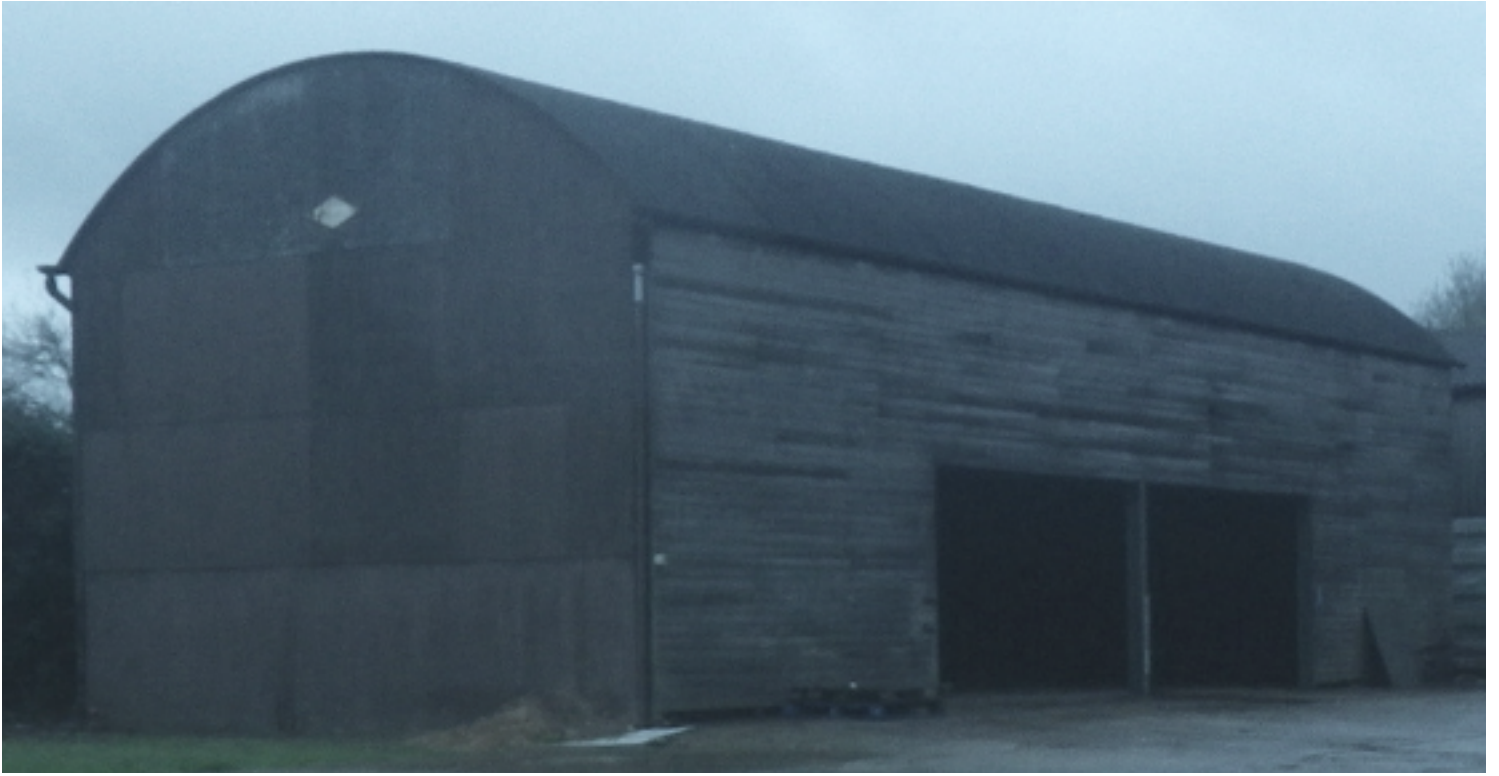
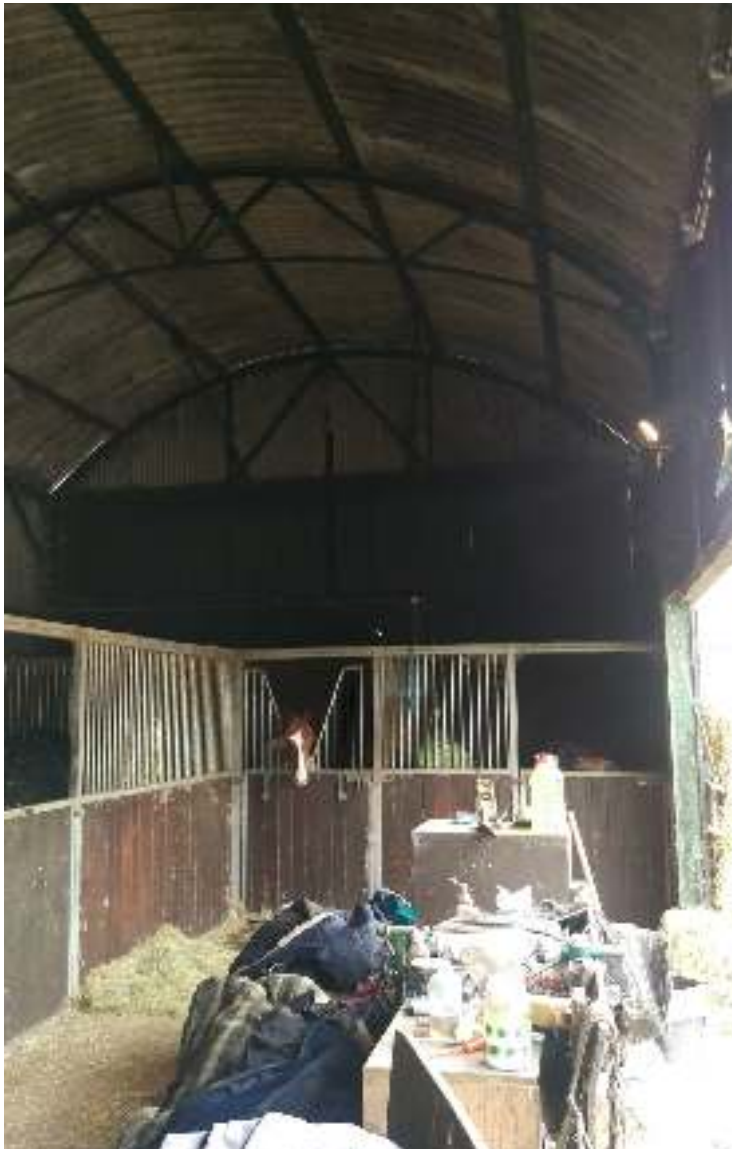
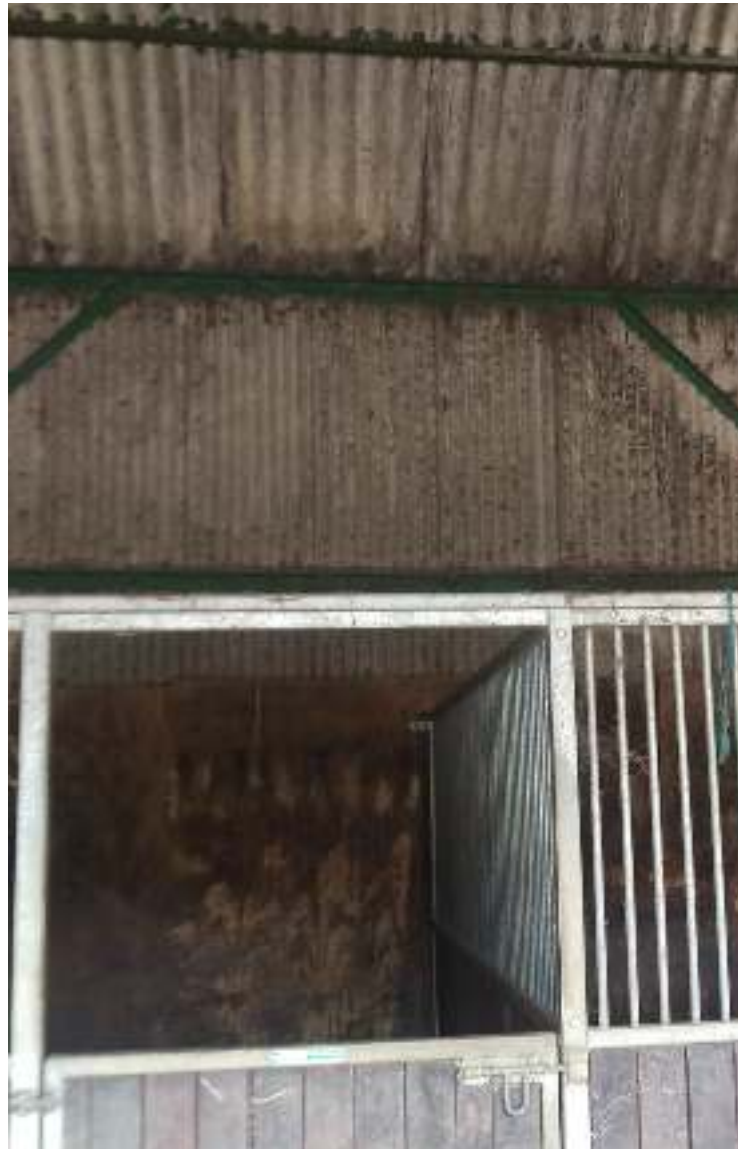
BEFORE

Ltd removed the crysotile cladding from the cowshed and stripped the remaining materials.

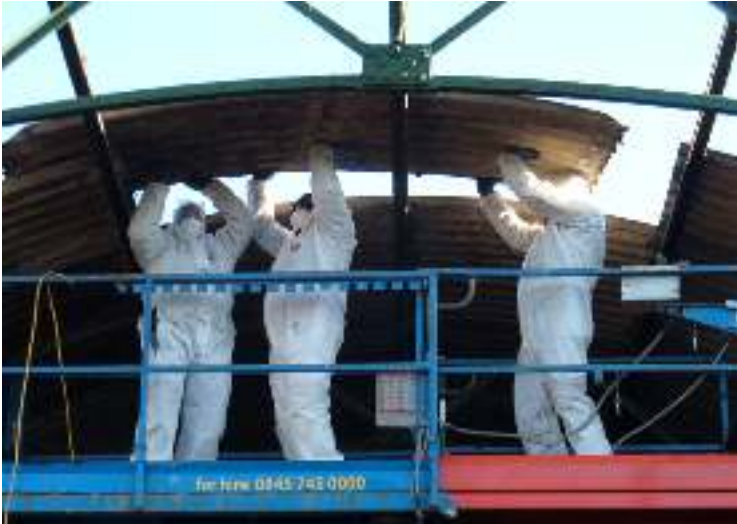
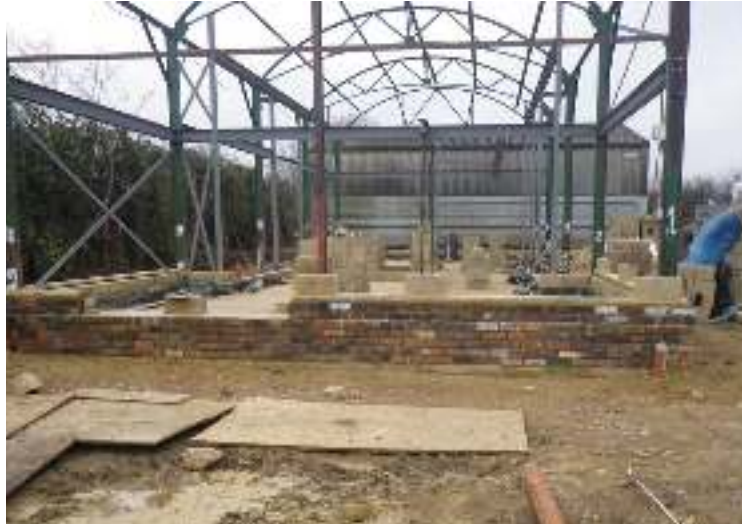
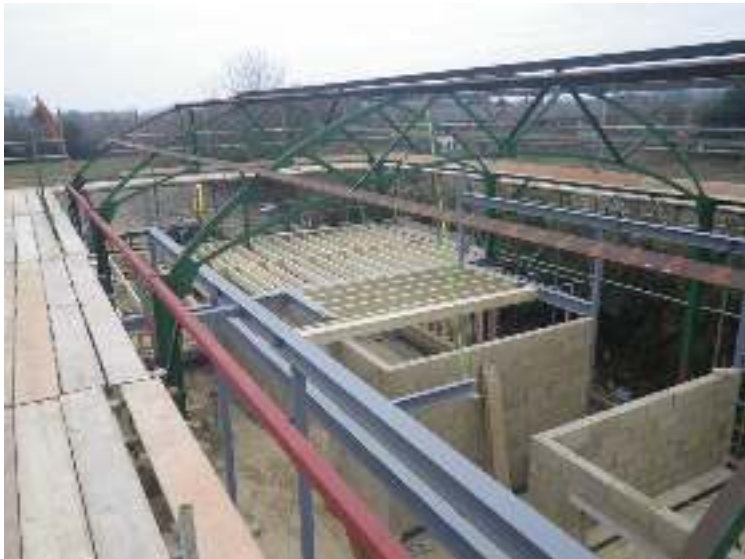
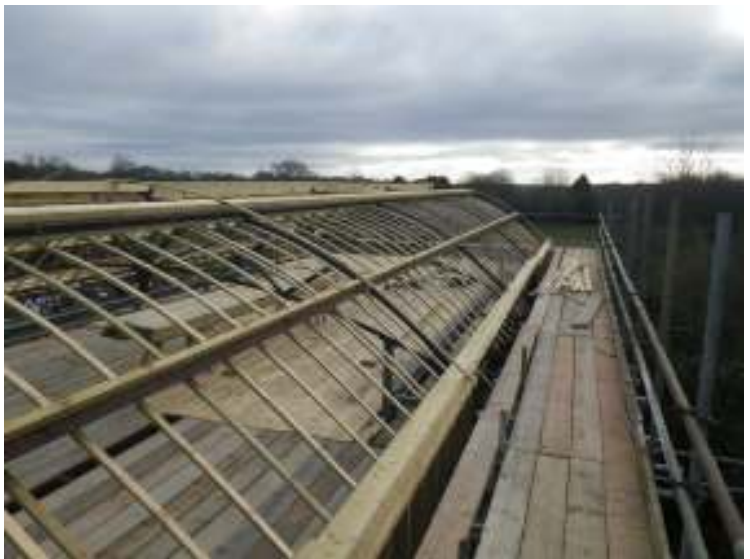
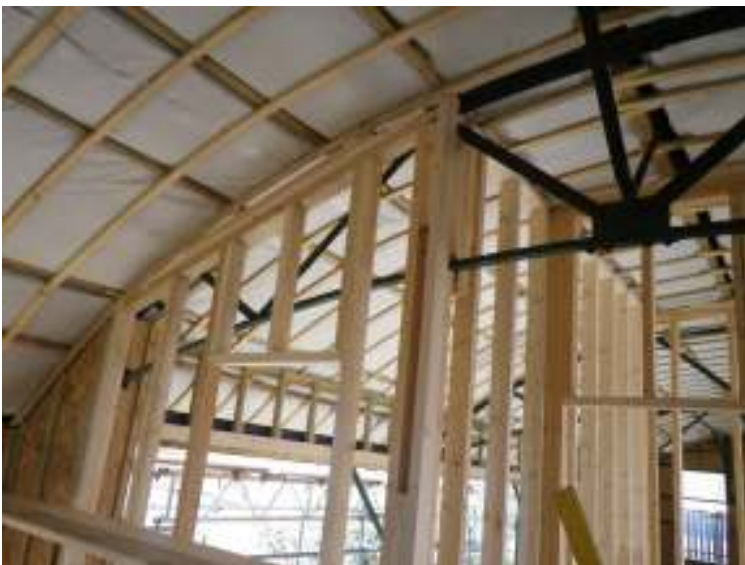
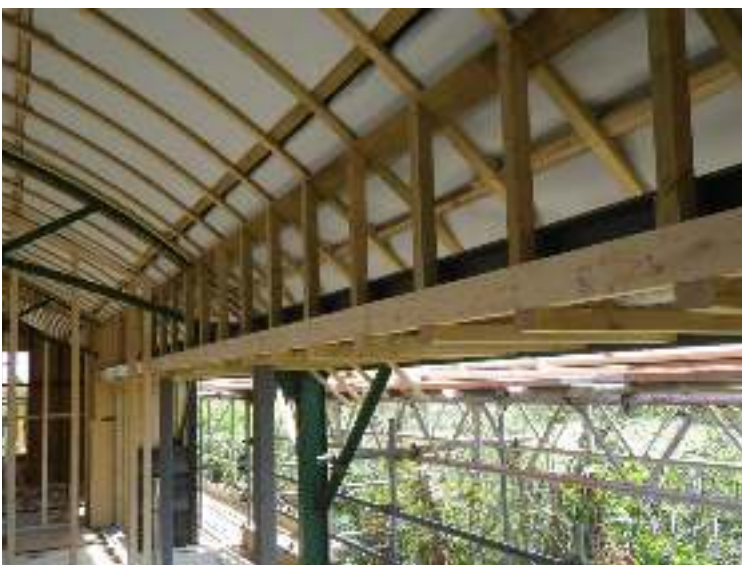
DURING

The footings were concreted and a dwarf wall was built to support the timber frame super structure. All of the original stanchions were incorporated into the external skin and roof, new walls were built to support the internal steels that were to take the first floor once the timber structure was complete.

It was insulated using paverflex insulation and isolair board and the exterior was clad with traditional feather board cladding.

Electrics and plumbing were installed as well as roof sheets and windows.

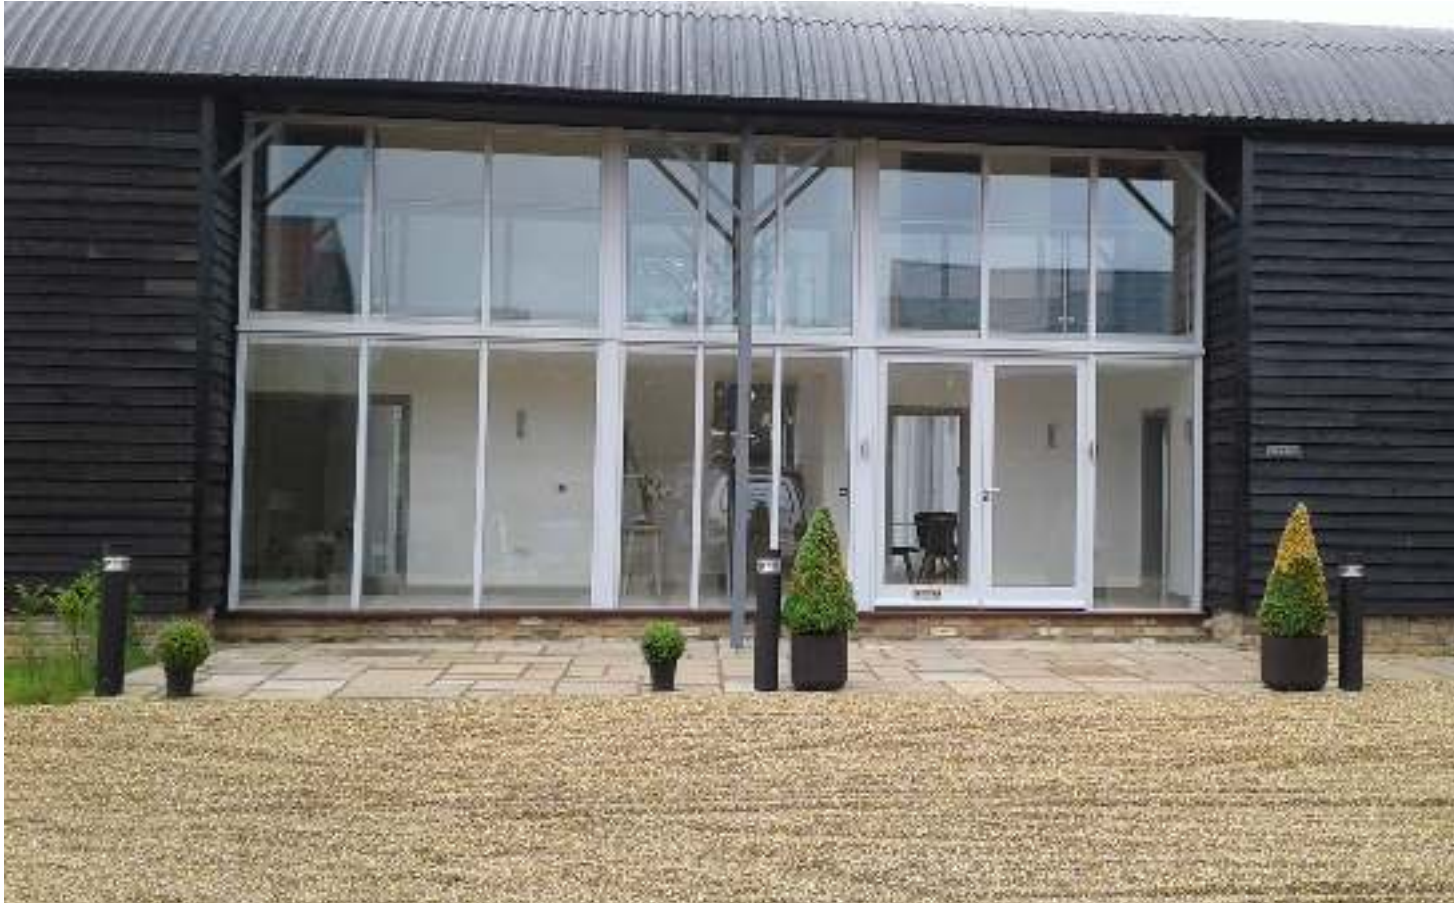
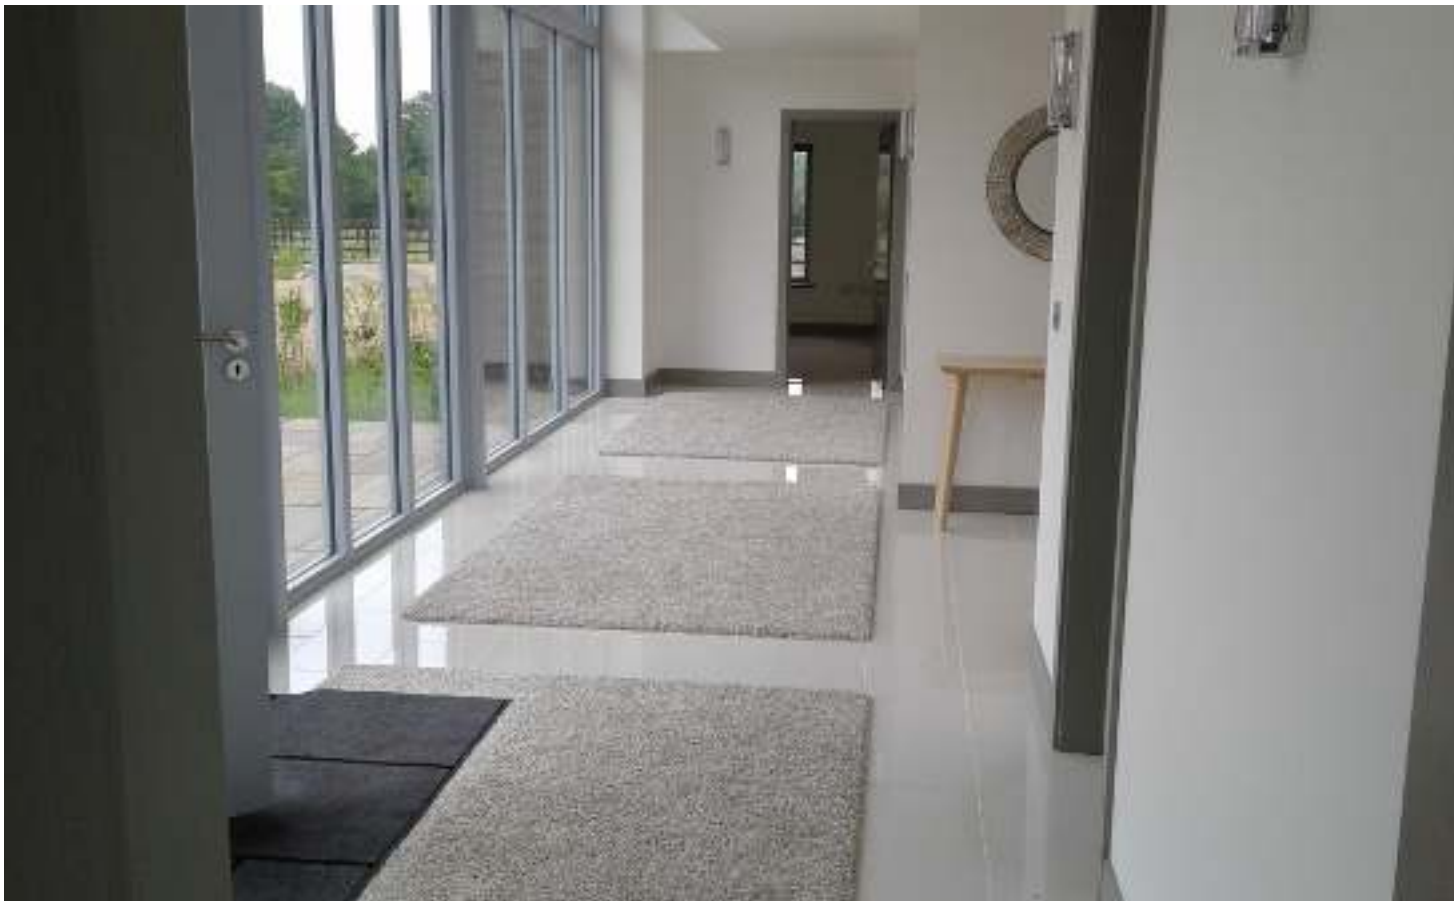
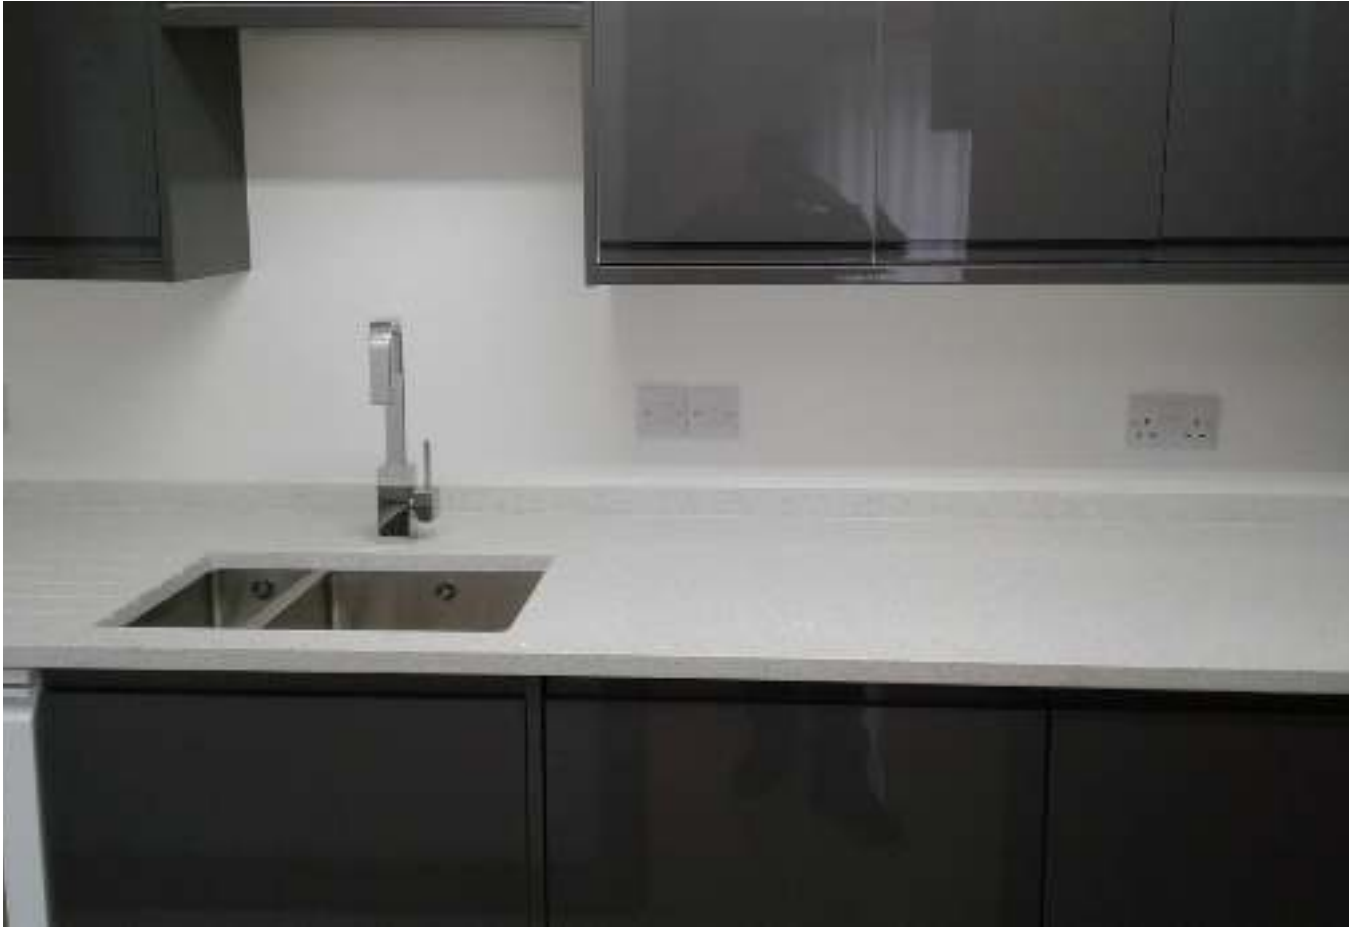
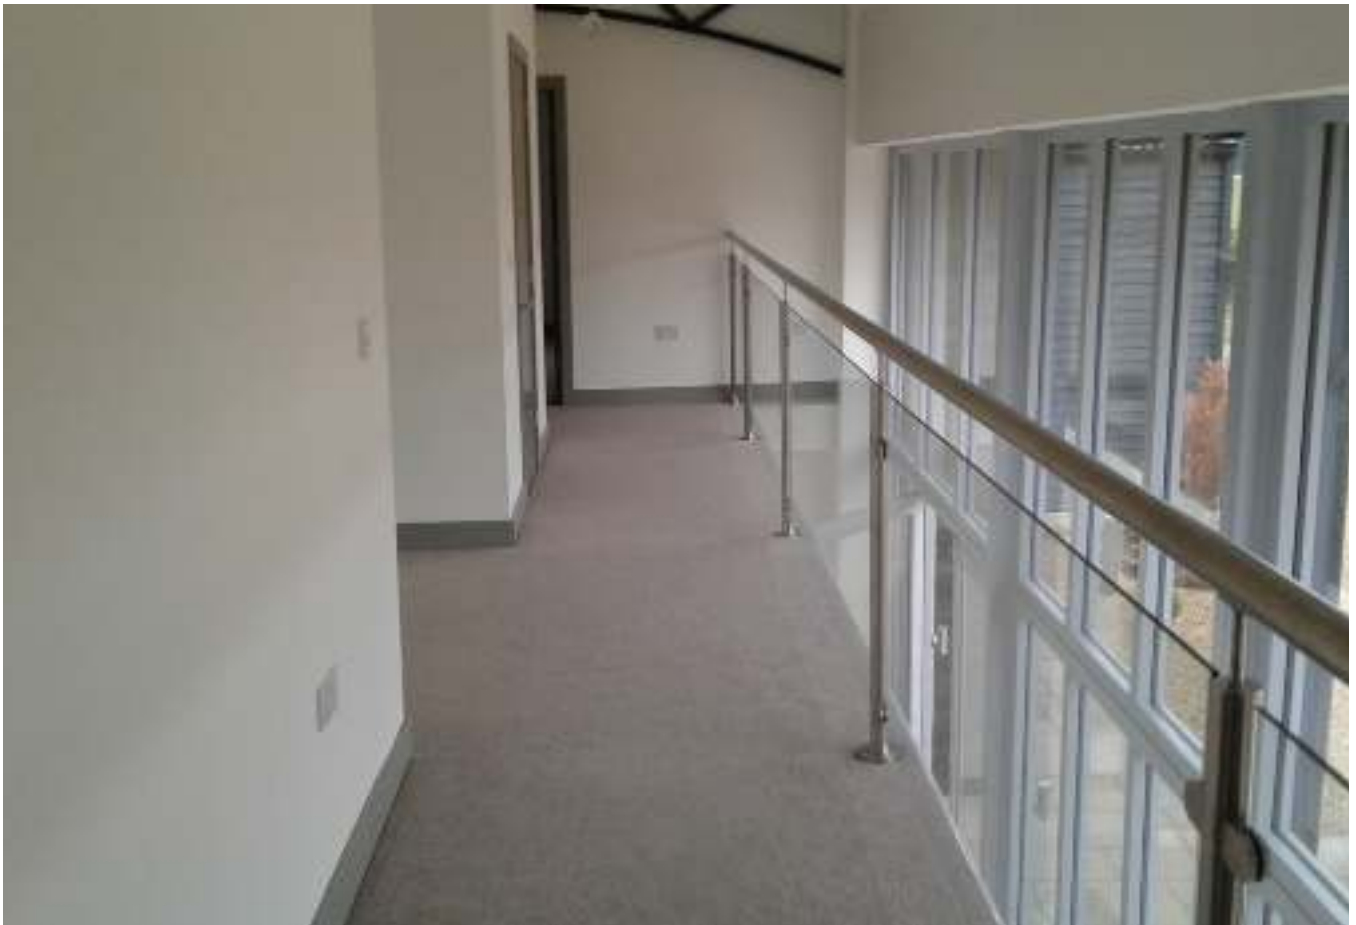
AFTER

The plastering was competed to a high standard, despite the curved ceilings, and the carpentry and door fittings and top spec kitchen followed suit.

All details such as decorating were finished last and the property was left in the highest standard.
